XIII Marovisz conference EGER 21-23rd March 2023

**THE ROLE OF NDT IN FRACTURE MECHANICS
AND STRUCTURAL INTEGRITY ANALYSIS**

Mirjana Opačić¹, Lazar Jeremić¹, Nikola Milovanovic¹, Aleksandar Sedmak²

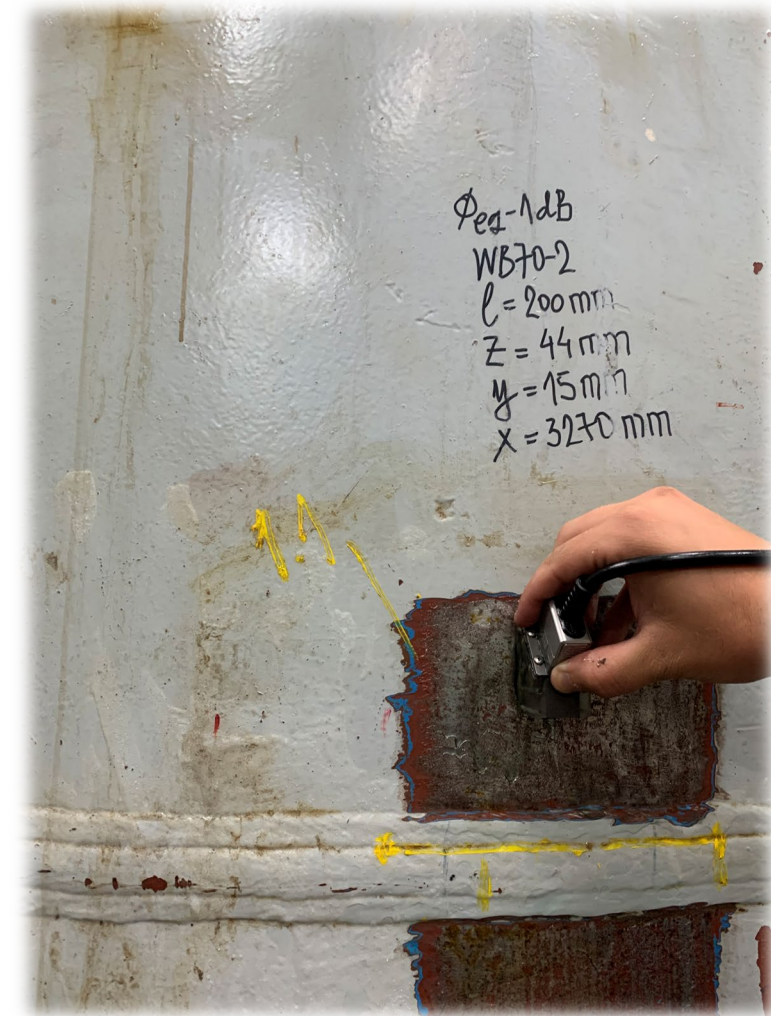
- PAUT is the newest and most advanced method of ultrasonic testing. The PAUT probe usually consists of eight small ultrasonic transducers, and each can be independently pulsed. By making the pulse delay from each transducer in the timely manner, a pattern of constructive interference is set up. To be more precise, by changing the progressive time delay, the beam can be steered electronically, and the data from those beams can be put together to make a visual image that shows a slice through the object. PAUT tests was also performed for all welded joints (100% scale), in accordance with the acceptance criteria as defined by the corresponding standard. During ultrasonic inspection, several defects are noticed in certain welded joints.

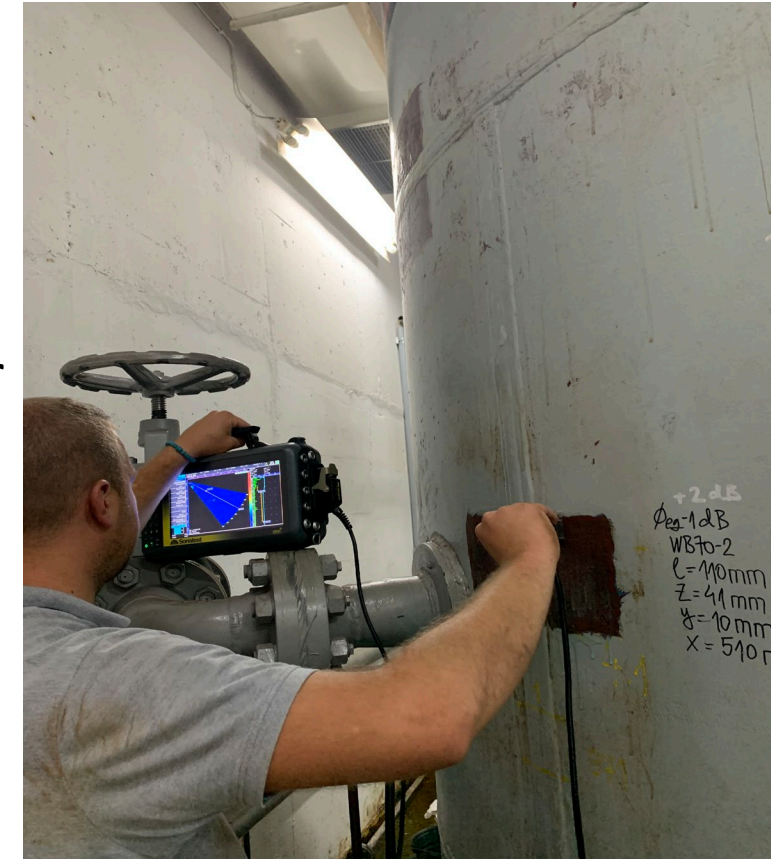
- Phased Array Ultrasonic Technique (PAUT) method of ultrasonic testing is used in this particular case due to its accuracy and sensitivity to confirm previous defect indications and to indicate new ones which was not possible to detect with conventional UT.

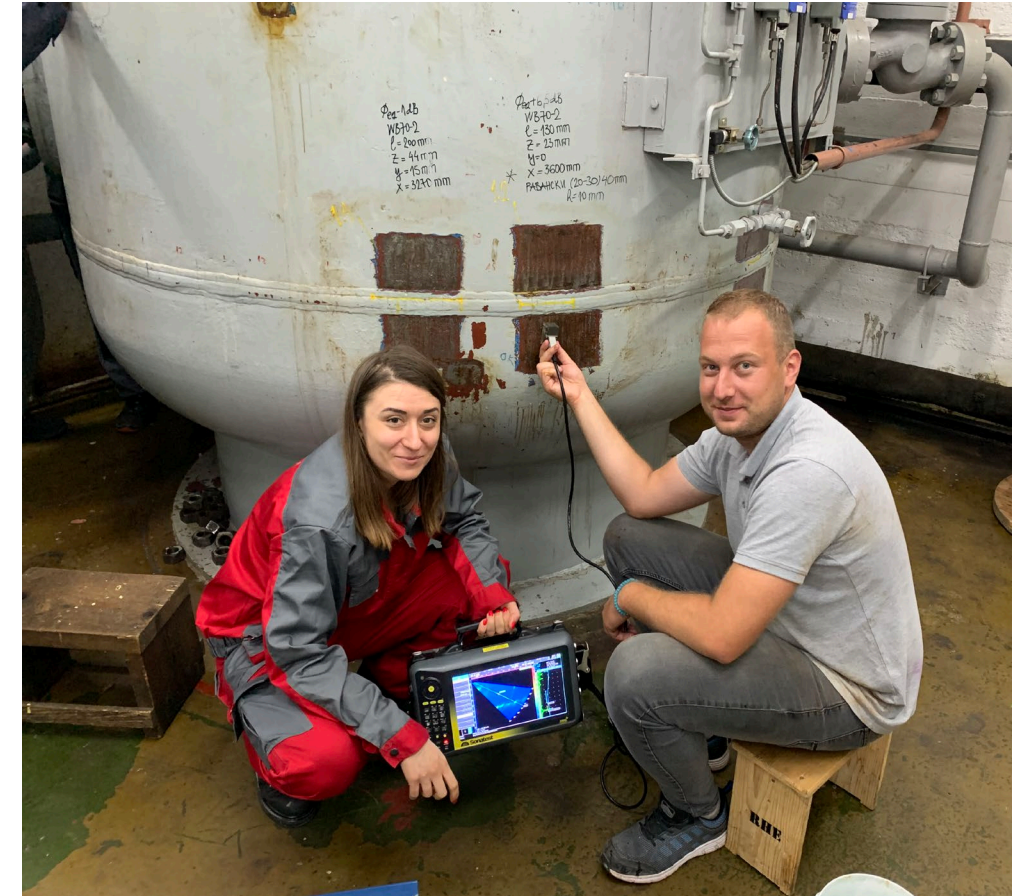
- The inspection and assessment of pressure equipment is performed according to the PED Directive 2014/14 / EU, and according to the standard EN 13445: 2015. In the further discussion, specific cases will be considered, and these are pressure vessels that belong to the Reversible Hydropower Plant "BAJINA BAŠTA.
- Inspection and testing of vessels under pressure, was performed by advanced NDT methods, which have a wide application in all areas of industry, not only in pressure equipment. For internal errors, the ultrasound method according to the standard SRPS EN ISO 11666: 2018/ was applied. In general, ultrasonic testing is mostly used in the testing of pressure equipment, which in this case proved to be the most reliable technique in detecting errors. An analysis of the results of the advanced NDT methods applied to these vessels will be discussed

After the final conventional UT testing of all vessels, 3 of them are chosen for more detailed analysis:

- PV 977 with defect 2.5 (length $2c=170$ mm, depth $a=14$ mm, 28-42 mm along the thickness of the mid-circular joint),
- PV 971 - defect 1.1 (length $2c=180$ mm, depth $a=32$ mm, 18-50 mm along the thickness, circular seam with the bottom cover) and
- 970 - defect 5.6 (length $2c=75$ mm, depth $a=20$ mm, positioned along the thickness from 18 to 38 mm, in a longitudinal joint).

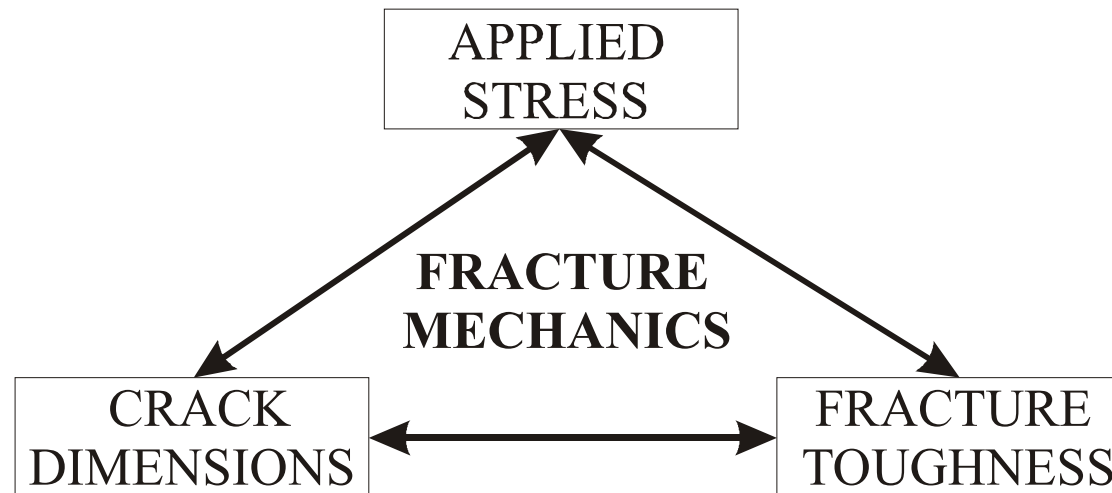
Figure 1. Fracture mechanics triangle

- Practical application of fracture mechanics is based on twofold interpretation of its parameters: on one hand, they represent loading and structural geometry, and on the other they represent material properties and its resistance to crack growth.
- In that way the triangle of fracture mechanics has been established, Fig. 1, enabling fracture mechanics to become one of the foundations of a new discipline – structural integrity. Thus, instead of only handling fracture analysis, fracture mechanics has become an important tool in the hands of engineers whose job is to prevent fracture.

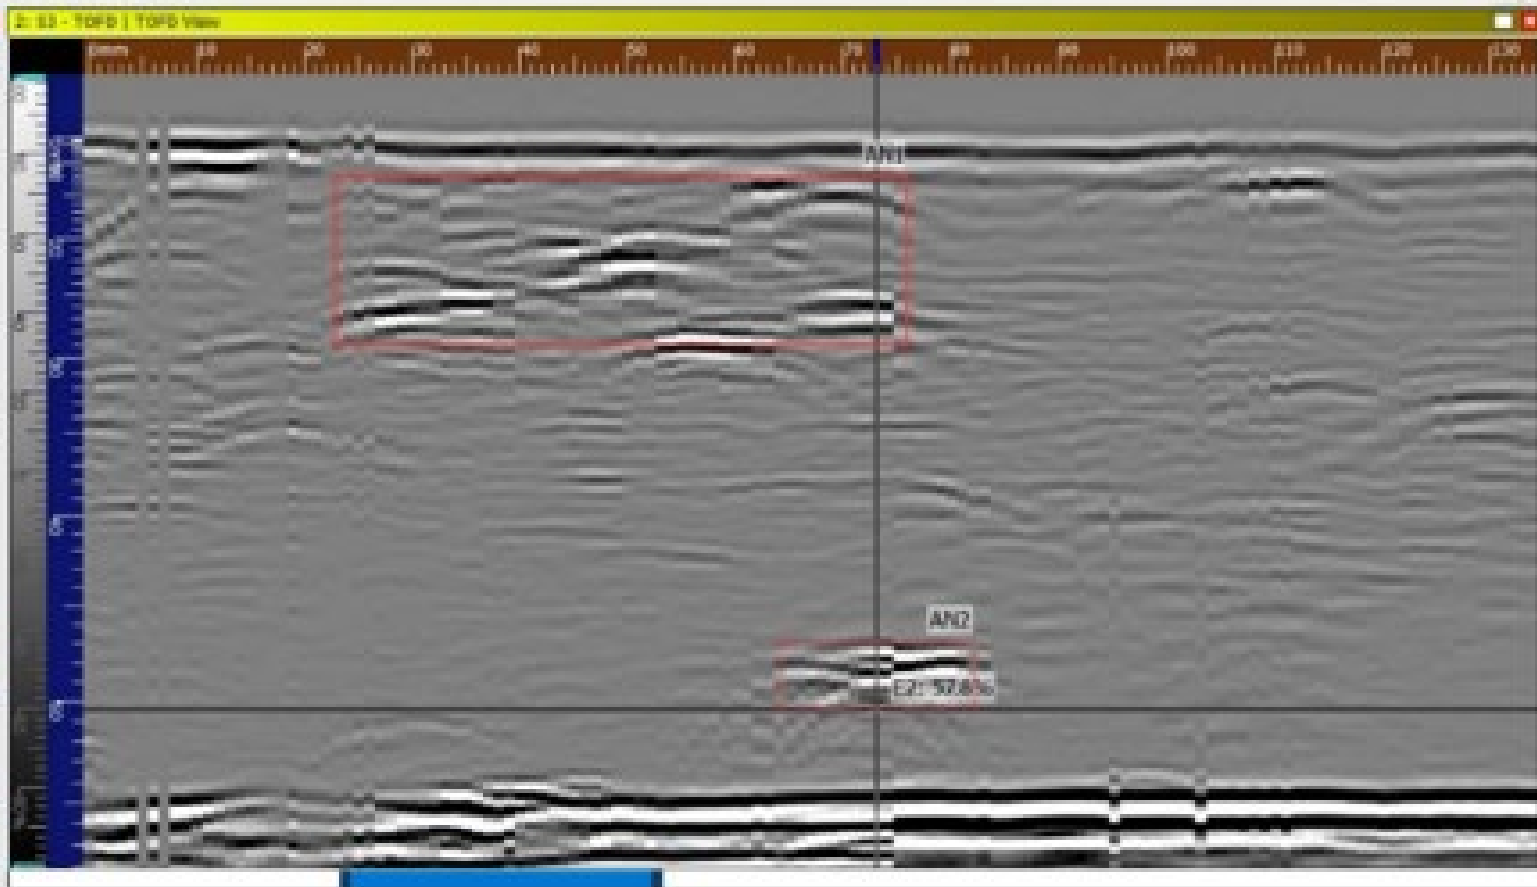
All necessary details of the UT testing by combination of PAUT and TOFD advanced techniques are presented in Fig. 4, where the first defect is denoted by AN1, and the second one by AN2.

Lock	Name	View	Defect Measurements									
			Scan 1	Scan 2	Δ Scan	Index 1	Index 2	Δ Index	Depth 1	Depth 2	Δ Depth	Area
<input type="checkbox"/>	AN1	2: S3 - TOFD TOFD View	23.09 mm	76.20 mm	53.11mm	--	--	--	12.34 mm	29.06 mm	16.72mm	888.20 mm ²
<input type="checkbox"/>	AN2	2: S3 - TOFD TOFD View	63.60 mm	82.38 mm	18.77mm	--	--	--	46.93 mm	50.41 mm	3.48mm	65.37 mm ²

S3 - TOFD

Type TOFD

Gain 83.0 dB

- The first one with length 53.1 mm, and depth 16.7 mm (from 12.4 to 29.1 mm);
- The second one with length 18.8 mm, and depth 3.5 mm, from 46.9 to 50.4 mm).

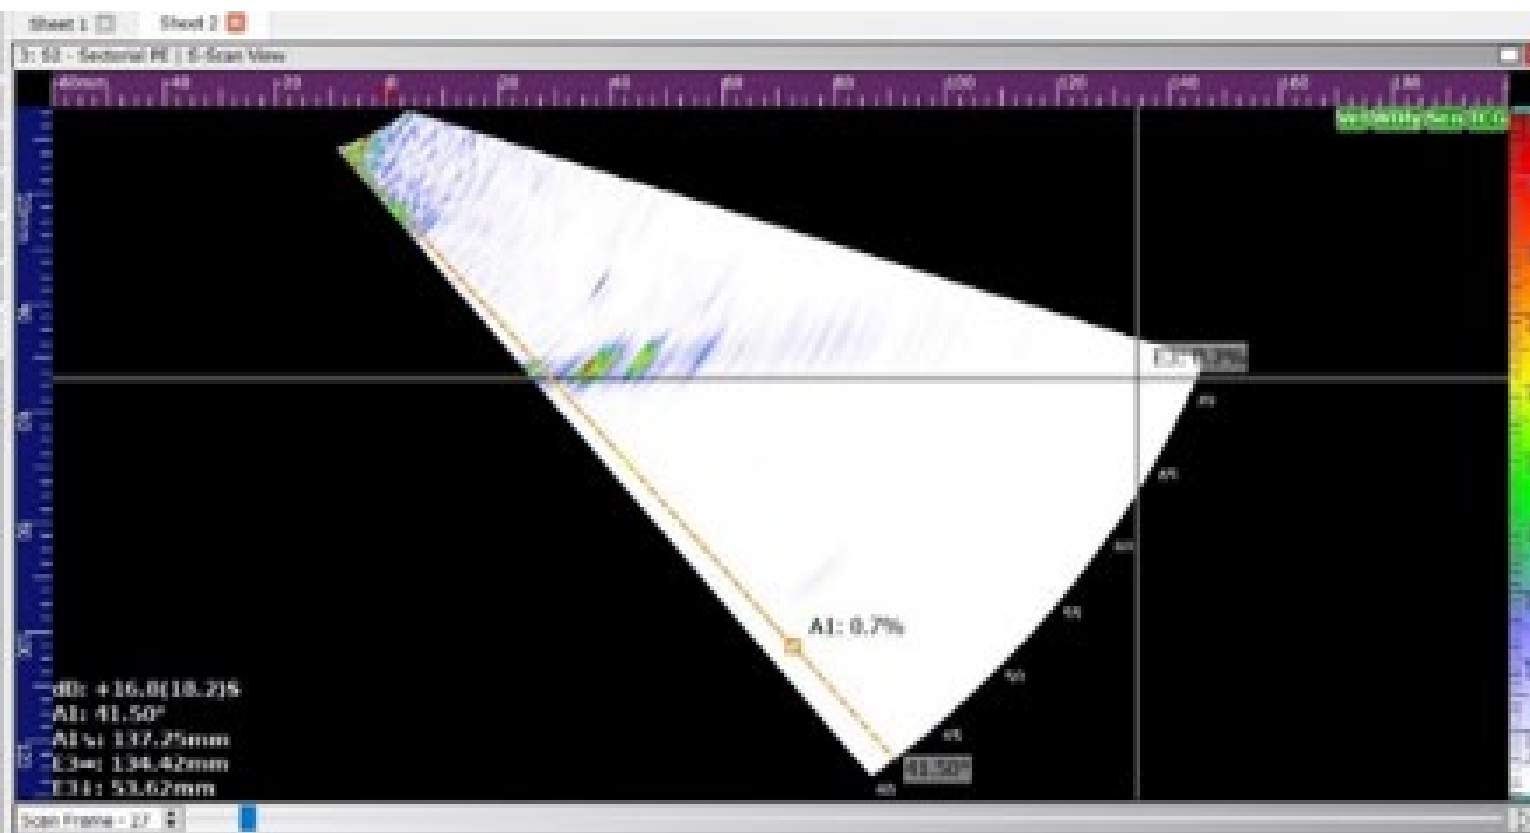
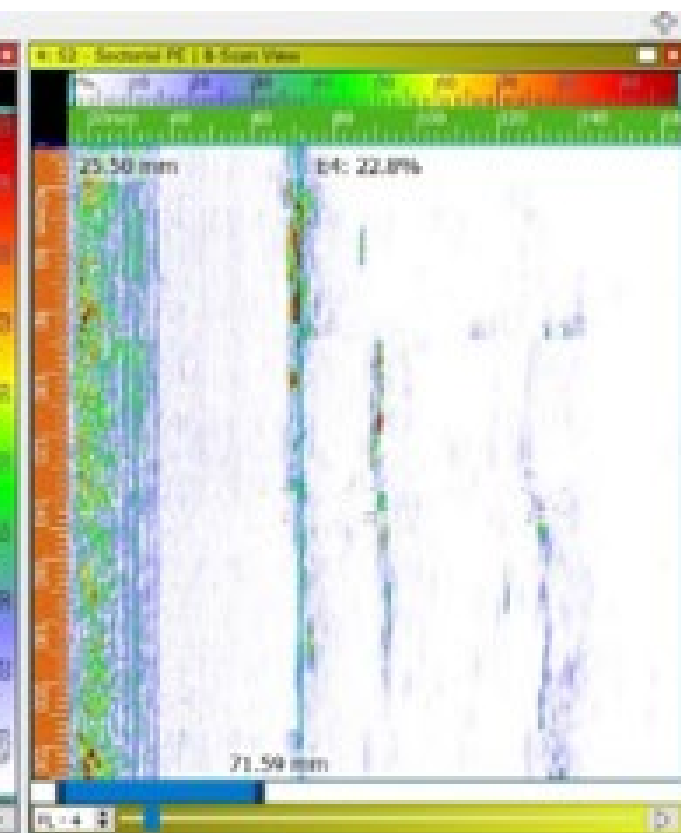
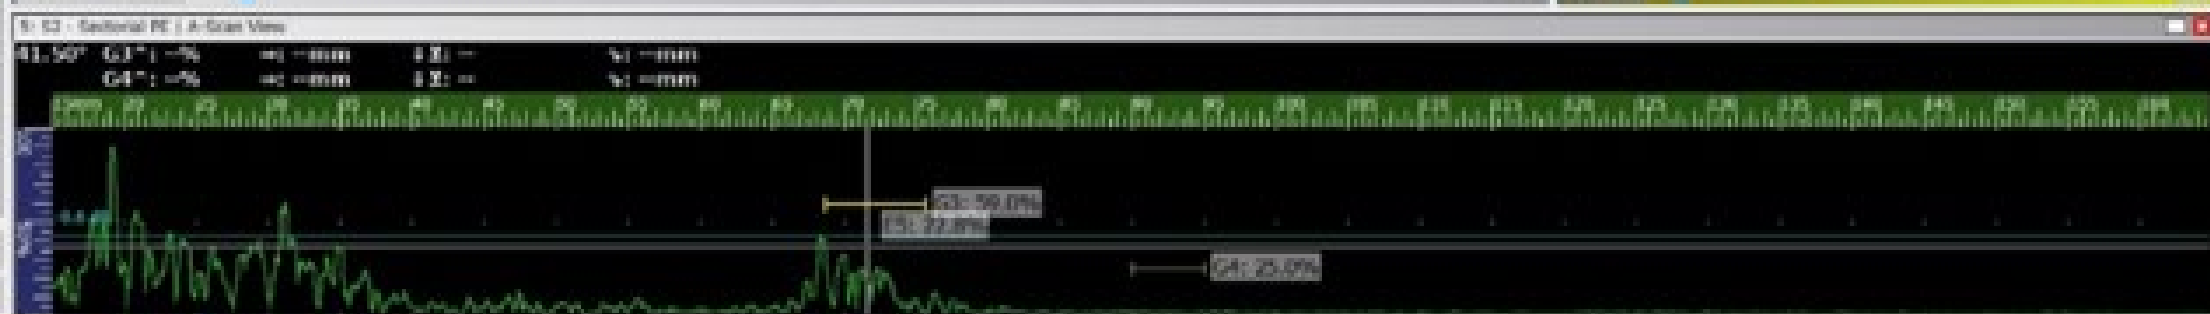
Lock	Name	View	Defect Measurements									
			Scan 1	Scan 2	Δ Scan	Index 1	Index 2	Δ Index	Depth 1	Depth 2	Δ Depth	Area
<input type="checkbox"/>	AN1	2: S3 - TOFD TOFD View	23.09 mm	76.20 mm	53.11mm	--	--	--	12.34 mm	29.06 mm	16.72mm	888.20 mm ²
<input type="checkbox"/>	AN2	2: S3 - TOFD TOFD View	63.60 mm	82.38 mm	18.77mm	--	--	--	46.93 mm	50.41 mm	3.48mm	65.37 mm ²

52 - Sectorial PE

Start Angle 40.00°

Stop Angle 77.00°
